## **ACOUSTIC EMISSION MONITORING OF IN SERVICE HARBOR CRANES IN ORDER TO PROGRAM MAINTENANCE OPERATIONS AND INSURE SAFETY MANAGEMENT:**

The plant of ArcelorMittal Fos-sur-Mer (France) is producing 4 million tons per year of hot rolled steel coils.

Two "Titan" harbor cranes are used in order to transfer the 40 tons coils on boats.

In order to detect unknown fatigue cracks propagation or initiation, an Acoustic Emission monitoring has been performed on the two harbor cranes. Especially for areas where traditional nondestructive testing methods are difficult to use.

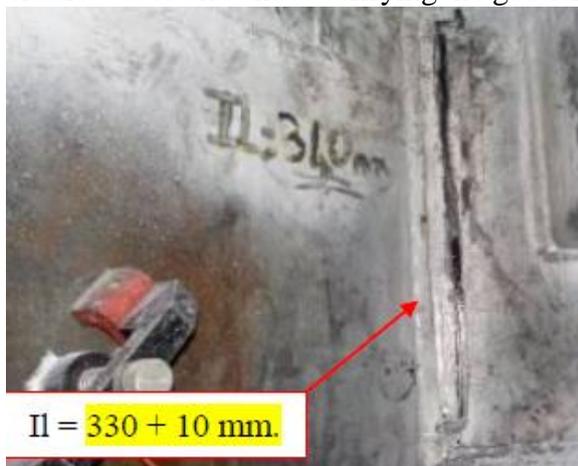
Sensors are maintained with magnetic holders and coupling is made with silicon grease. In case if AE source is located too close to AE sensors, those sensors can be dismantled easily in order to correlate and to measure the extension of the indication with traditional NDT. Furthermore it will avoid the degradation of sensors if a repair should be achieved (fig. 1). Some welding work can be done without removing the sensors and this is the reason why we stop to use integrated preamplifier (risk of local overheat during welding).

Figure 1: picture of a sensor near crack area.

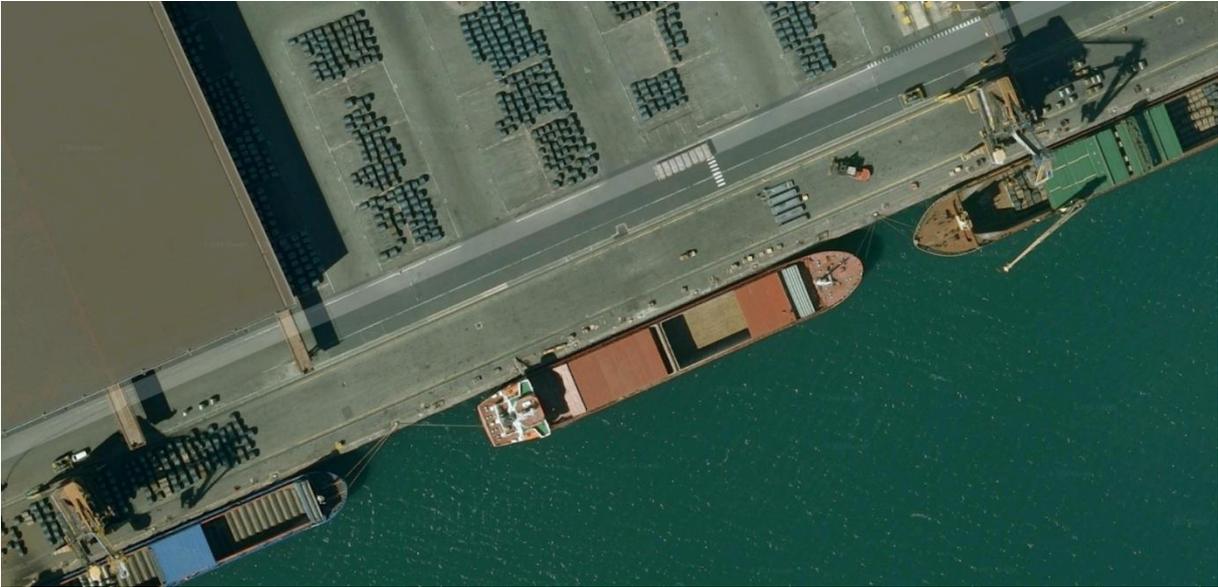
Two Titan harbor cranes (N° 730 and 731) are used to transfer the 40 tons coils into the boats in the harbor side of Fos sur Mer. The cranes are moving on rails along the piers to approach the boat (fig. 2). Then to load it they have to rotate to deliver the 40 tons coils.

Figure 2: situation of the two cranes on the harbor of Fos sur Mer.

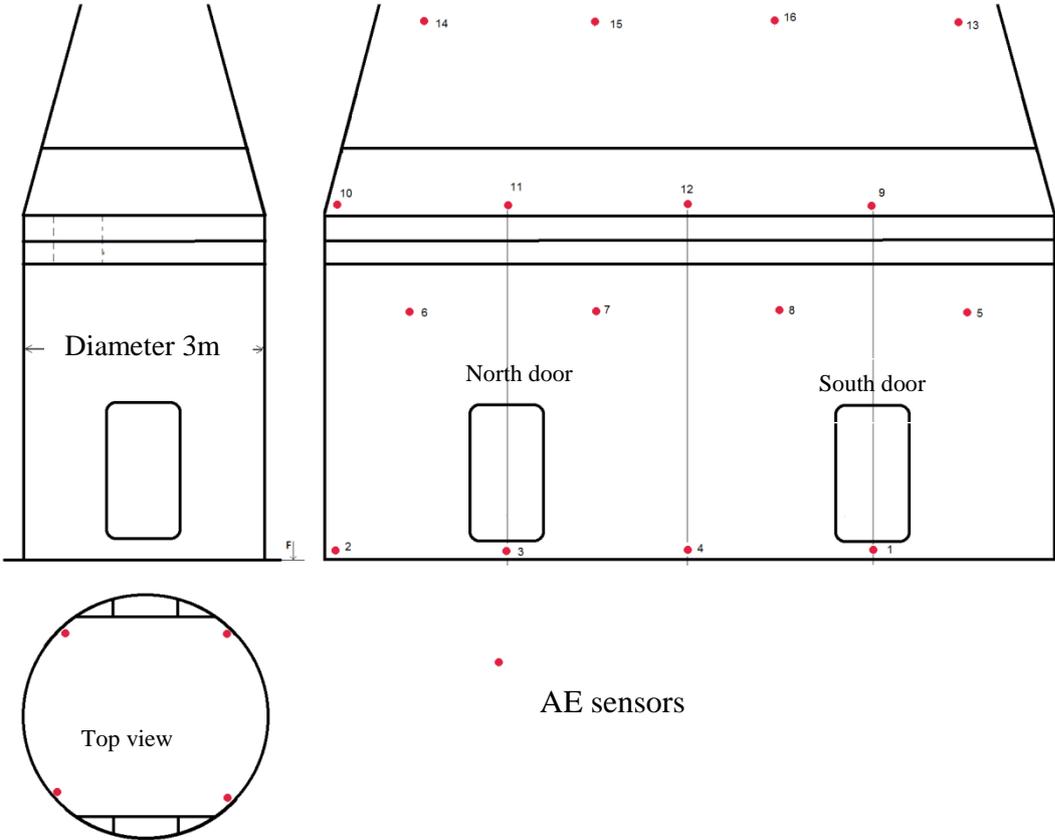
Figure 3: schematic drawing of the monitored fixed part of the crane with the position of the sensors.

The main cracking area discovered in 2015 on the crane internal structure. It can be represent by a cylinder ended with a conical shape which is represented on figures 3 and 4. Figure 3 is showing the sensor layout. At the level of sensors 9 to 12, there is the tread pattern of the crane where the rotation is guided.

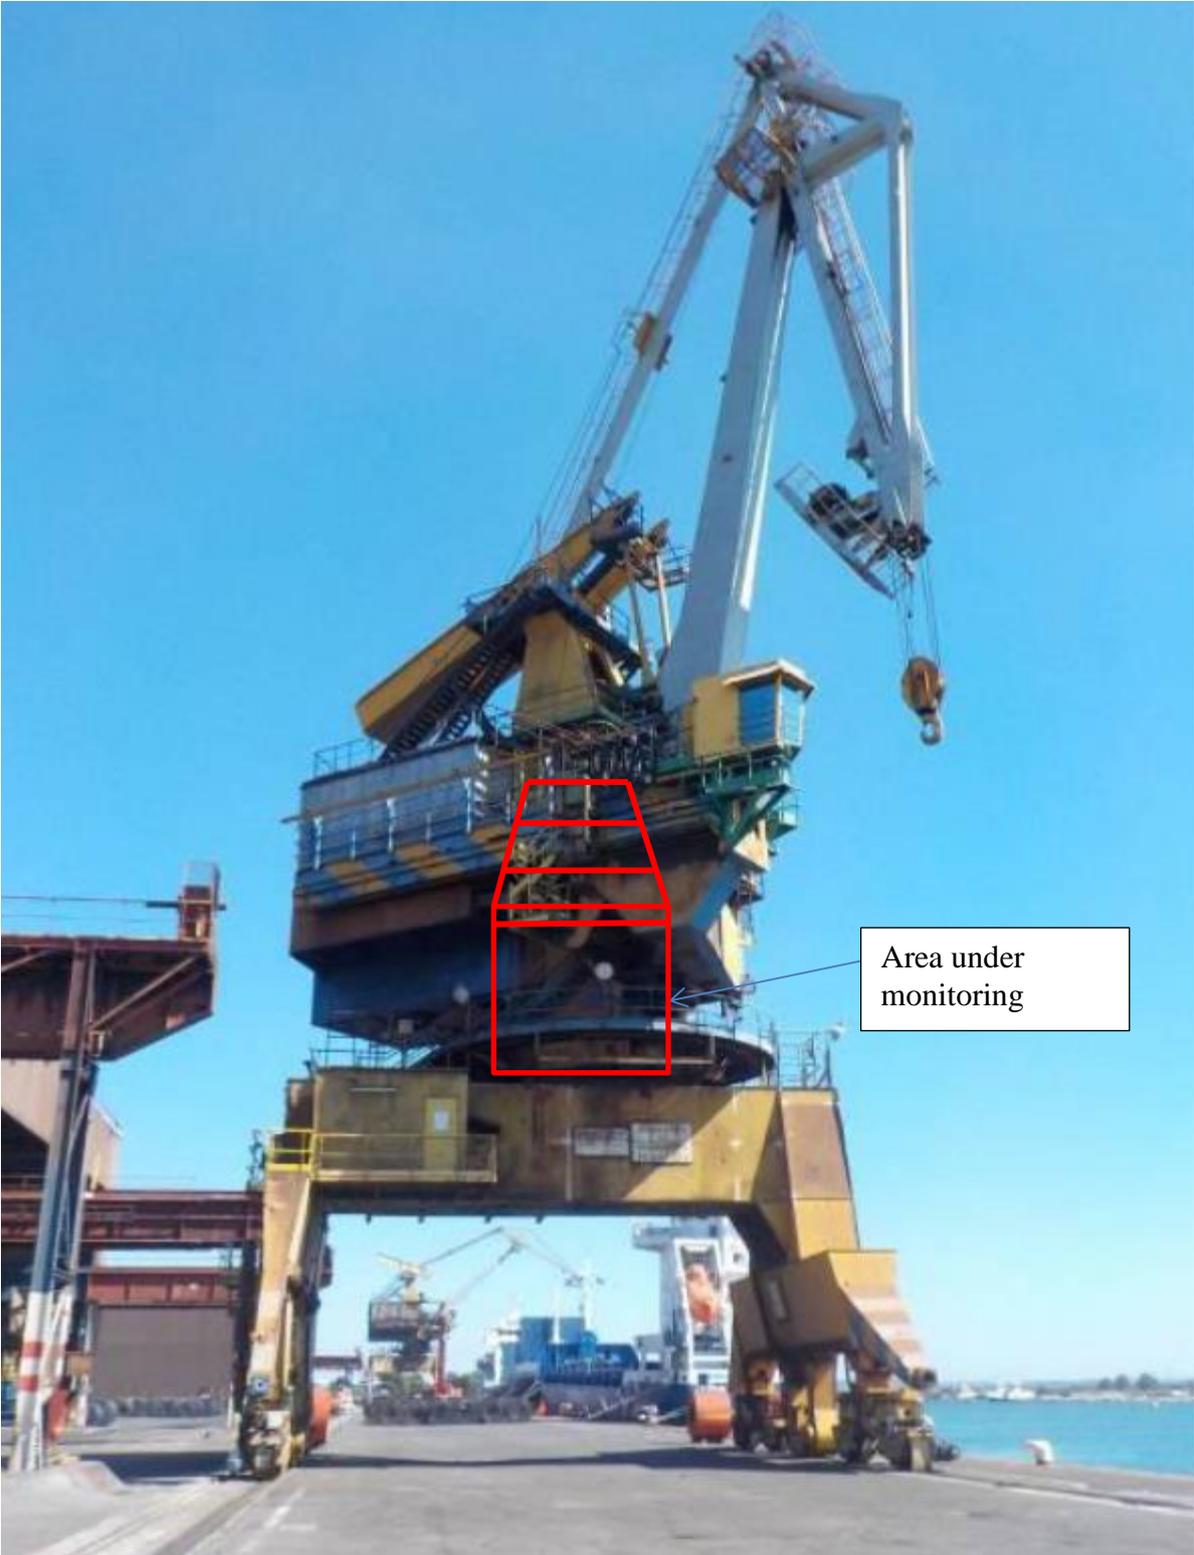
Figure 4: View of N°731 titan crane and area of interest.

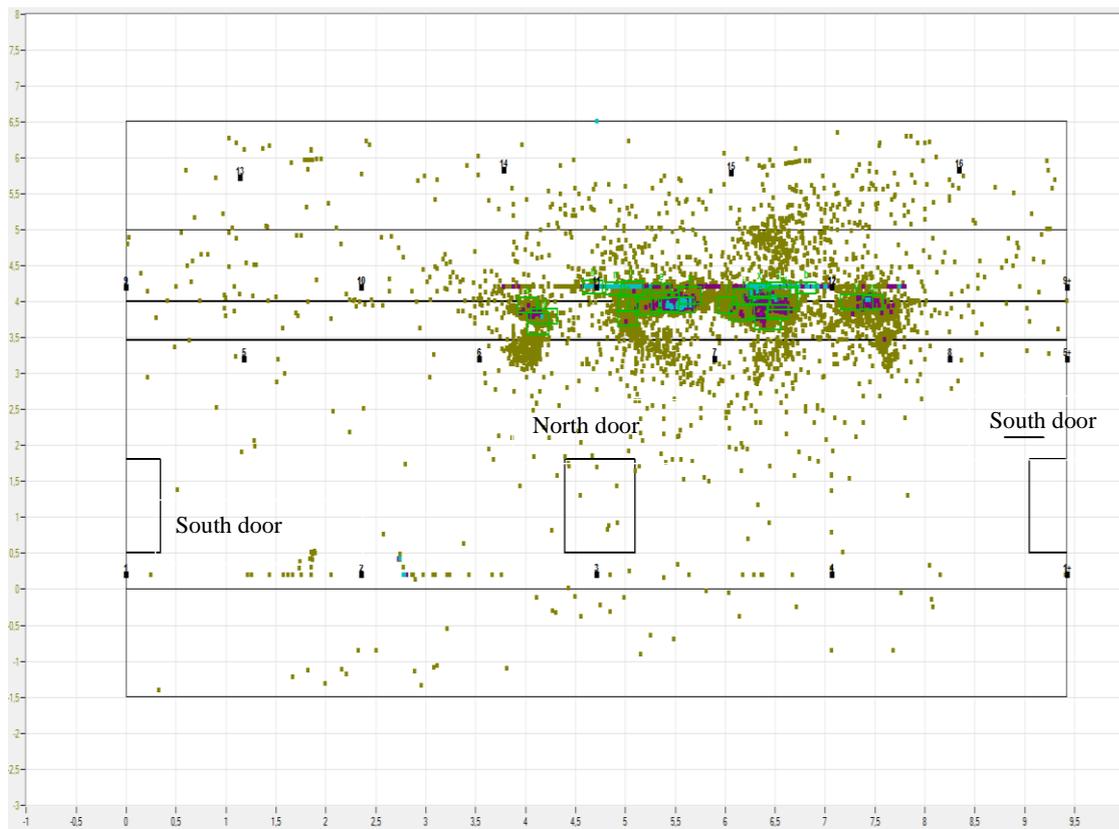
The progressive phases of loading at the maximum load did not generate a significant AE activity. The main recorded activity has been detected during dynamic tests with no load with the crane boom lifted near the verticality. The location processing indicates localized activity mainly in the tread pattern in front of bearing rollers. Figure 5 gives an example of location map during dynamic test of N° 731 crane. No other significant indication has been detected during these loading tests only stress release in the tread pattern area.

Figure 5: Location AE Map of Titan crane during dynamic phases of proof test.

Based on the analysis of proof test, an adapted AE filter has been built. After this real time noise rejection of data the monitoring is producing readable and genuine information.

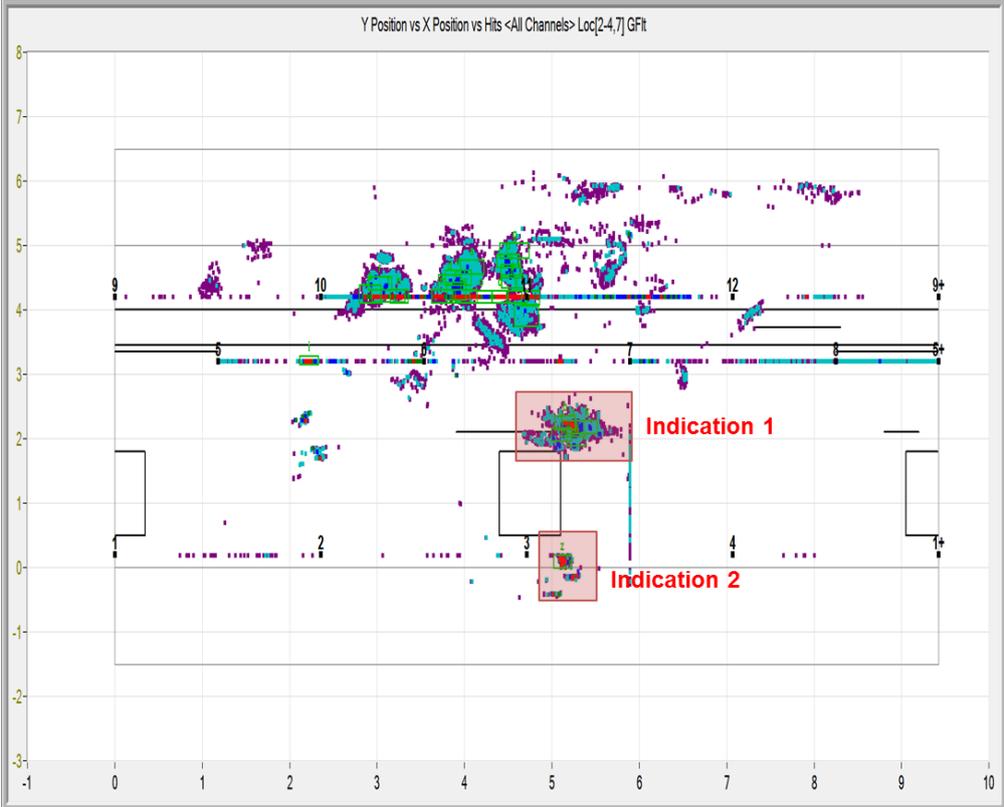
Figure 6 gives an example of one week location map that indicates several sources crossing the warning level in term of cluster concentration and emissivity history. After internal inspection (MP and UT) and cracks sizing, it has been decided to repair the area of source 1 and 2. Figure 6 shows also an important AE emissivity near to the zone of the tread pattern (sensor 10, 11 and 12).

Figure 6: One week location map on N°730 Titan crane.

The monitoring results just after repair gives a great reduction of AE activity in these 2 areas.

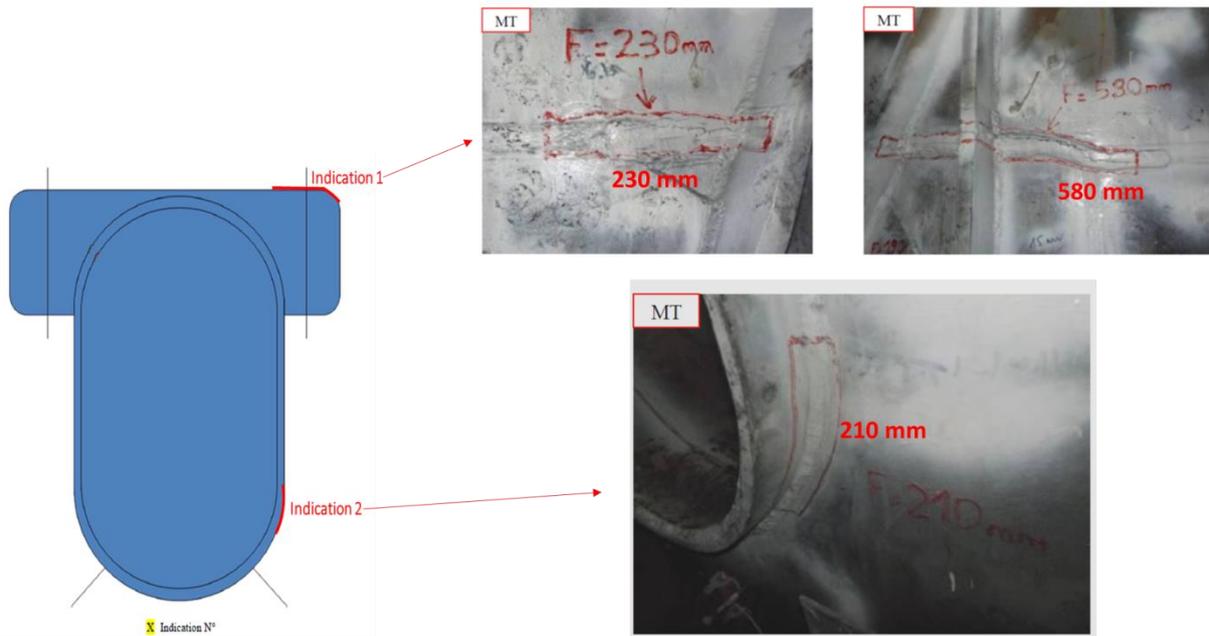
Figure 7 give evidence of superimposition of multiple cracks propagations in the area near to the south door (sensor 3).

Figure 7: sizing of the indications in the AE source areas (MP and UT).
