Manufacturing of Calibration Samples for Barkhausen Noise Method: Case Studies on Temperature Controlled Laser and Hydrogen-Oxygen Flame

Suvi Santa-aho¹, Murat Deveci², Samuli Savolainen² and Minnamari Vippola¹
1 Tampere University of Technology, Laboratory of Materials Science, Finland,
suvi.santa-aho@tut.fi, minnamari.vippola@tut.fi
2 Stresstech Oy, Vaajakoski, murat.deveci@stresstech.com,
samuli.savolainen@stresstech.com

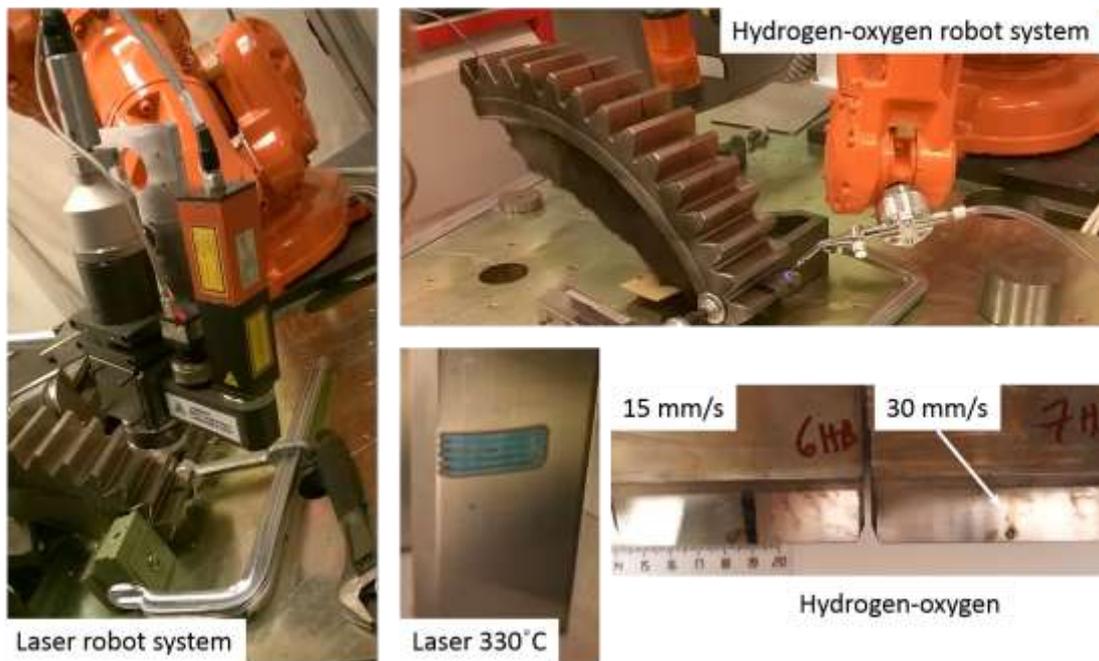
Figure 1. Robotic assembled laser system and hydrogen-oxygen flame burner system with examples of produced tempered marks with 330 °C laser and production speeds of 15 mm/s and 30 mm/s with the hydrogen-oxygen burner.

The studied samples were flame cut parts of a planet gear manufactured from 18CrNiMo7-6. The initial state of the gear wheel was a carburising case hardened after grinding. The gear teeth height was 83 mm. Two pieces were prepared with different processing systems. A robot controlled system, presented in Figure 1, was tested to

Temperature controlled laser processing was carried out with fibre-coupled diode laser Laserline LDM 400-300 with wavelength of 940 nm. The temperature controlled laser processing utilised a real-time infrared ratio quotient pyrometer control to change the diode laser parameters for keeping the surface temperature constant regardless of the surface condition (absorption changes) of the sample. Totally 10 different thermal damages to separate gear teeth within temperatures between 250 °C and 330 °C were processed. The laser head traverse speed 3 mm/s was kept constant. The laser head was kept at 90° in relation to the tooth flank surface. The laser mark was produced with separate laser processed lines that were done from the tip area towards the bottom area and vice versa totally 10 times with a step of 0.7 mm to produce a uniform mark with a width of 0.7 mm.

challenges with the reproducibility of flame processing. Therefore, the same robot as in laser studies was programmed. Robot control enabled the process to have different and more controlled test parameters which could be varied: the speed of the flame, the width of the mark (controlled as the number of paths) and the distance of the flame from the surface of the sample. During robotic hydrogen burning process, the pressure of the system was set to 140 mbar and during the processing, it was verified to be about 94 % of the set-up value. The used nozzle's diameter was 1.2 mm producing marks with 1 mm width. The automated robotic processing system allowed to vary the process speed from 15 to 45 mm/s. The number of paths in each of the marks were varied either 2 or 4 producing thermal damages with a total width of 2 – 4 mm. Two samples, with production speeds of 15 and 30 mm/s with 2 paths and 3 mm distance between flame and surface were selected for further studies.
